Manhole Inspection Summary

Manhole # S05AA2038MH

Insp Date: **8/17/06 12:00 AM**

Location Address: **5942 CROSS COUNTRY BLVD** Cross Street: **PARKINGTON AVE**

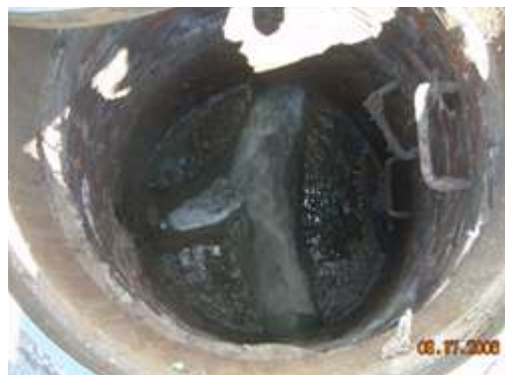
Top View

Frame leaks. Adjustment, Corbel and Barrel infiltration. Corroded steps.

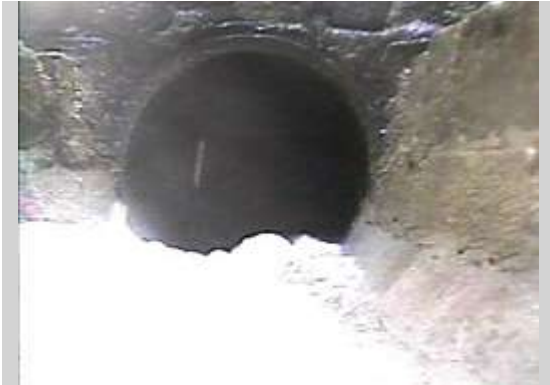
10 in. Circular Gravity Sewer Pipe Out @ 12 O'Clock

Infiltration: **Evidence** Pipe Seal Cond: **Cracked**

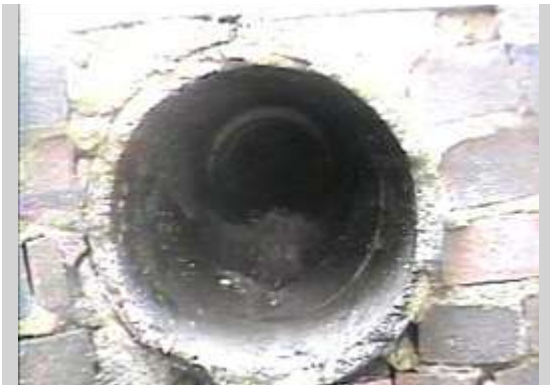
10 in. Circular Gravity Sewer Pipe In @ 5 O'Clock

Corbel deterioration and infiltration.

Infiltration: **None** Pipe Seal Cond: **Cracked**

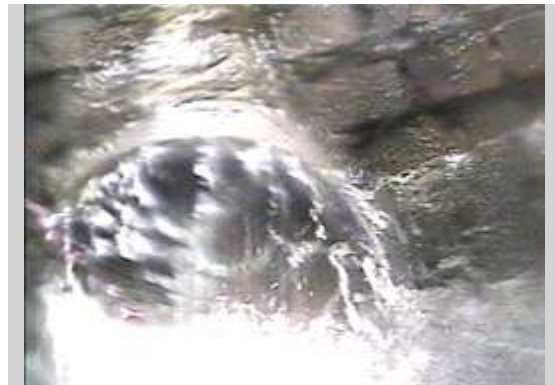
Drop In @ 5 O'Clock

Drop Condition: **Partly Clogged**

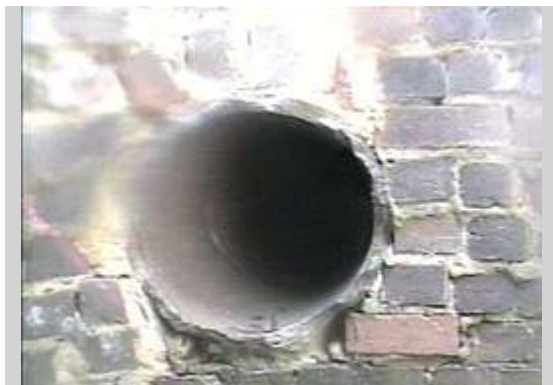
Pipe In @ 7 O'Clock

Corbel deterioration and infiltration.

Infiltration: **Evidence** Pipe Seal Cond: **Broken**

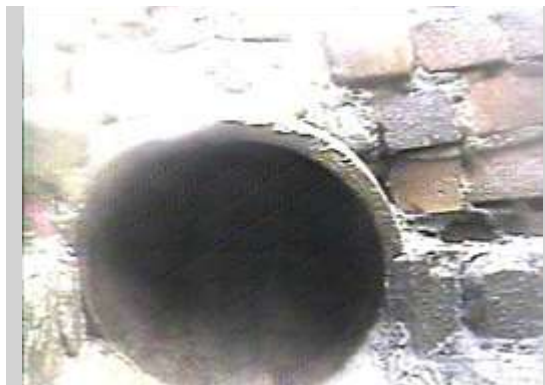
Drop In @ 7 O'Clock

Barrel deterioration and infiltration.
